IMPROVING THE LINING OF THE HEADRACE TUNNEL IN CHARCANI V POWER PLANT, RIO CHILI, PERU

Andriolo, F⁽¹⁾., Maffei, C.E.M.⁽²⁾, Ruiz, Murillo⁽³⁾

This paper describes the studies and solutions adopted leading to some original corrective measures for this particular kind of problem.

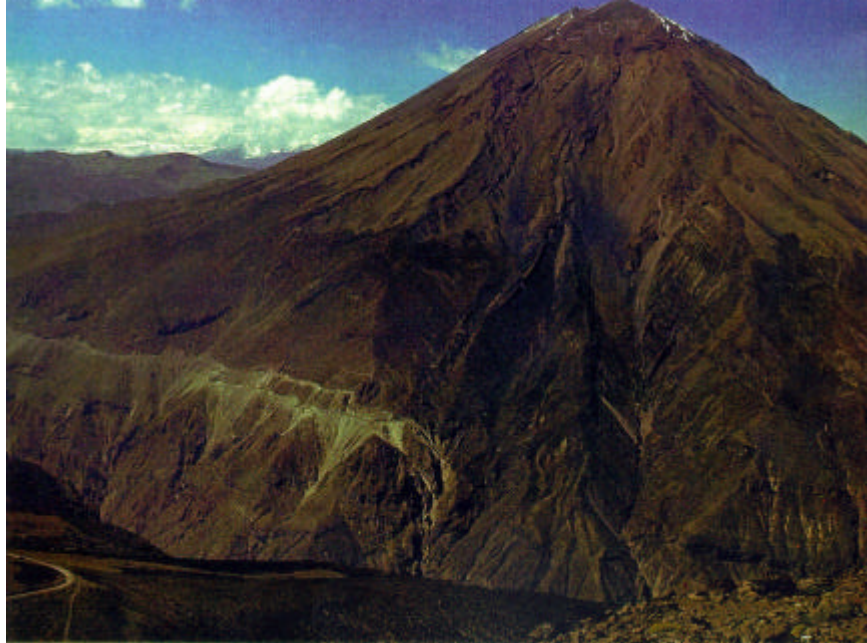
Figure 5 - The volcano Misti and location of works

The work is developed along the base of the volcano, where the river Chili eroded the local rocks forming a deep canyon. Figure 5 shows the volcano Misti and the relative position of the works.

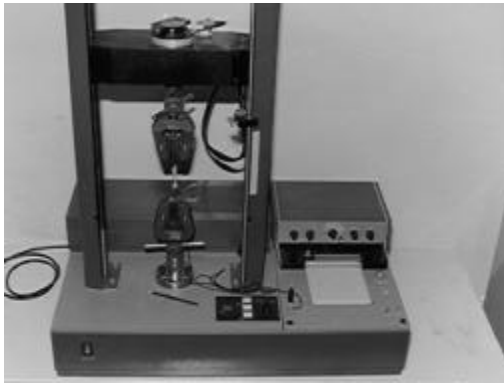
Figure 7 - The Instron machine used in the tests

The selected material to be used in the protection of the fissure was an adhesive tape, having 50mm width. In order to check the performance, two types of commercial tapes were tested in an Instron machine of 1,000kgf capacity, equipped with an extensometer to register the elongation (Figure 7).
