Concrete Expansions Due to Sulfates-Aspects of Limitations and Causes

ANDRIOLO, Francisco Rodrigues

Andriolo Engenharia Ltda-

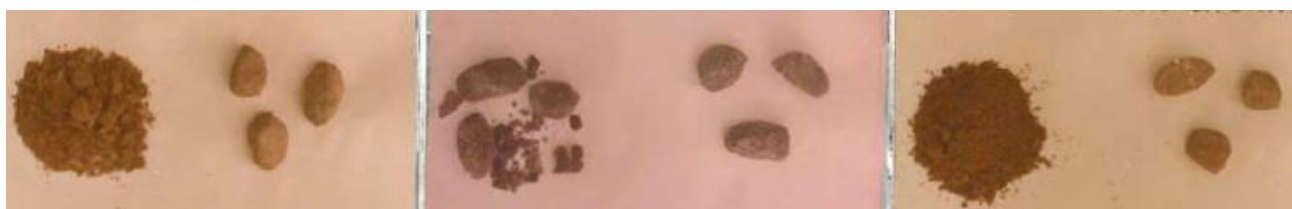
After test	Before test	After test	Before test	After test	Before test
------------	-------------	------------	-------------	------------	-------------

Soaking in Ethylene- Glycol – LCEC – CESP- Laboratory – Ilha Solteira- 1974

Figs. 2 – Aspects concerning expansive phenomena due to montmorillonite clays in the basalt under accelerated test

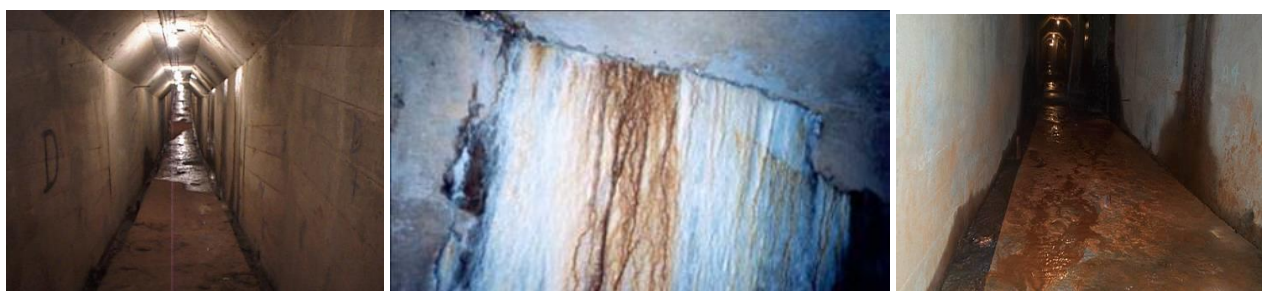
Figs. 5 – A gallery in a Dam; the leakage in a construction joint ad the sediment with a brown-red color inducing the sulfate [3]

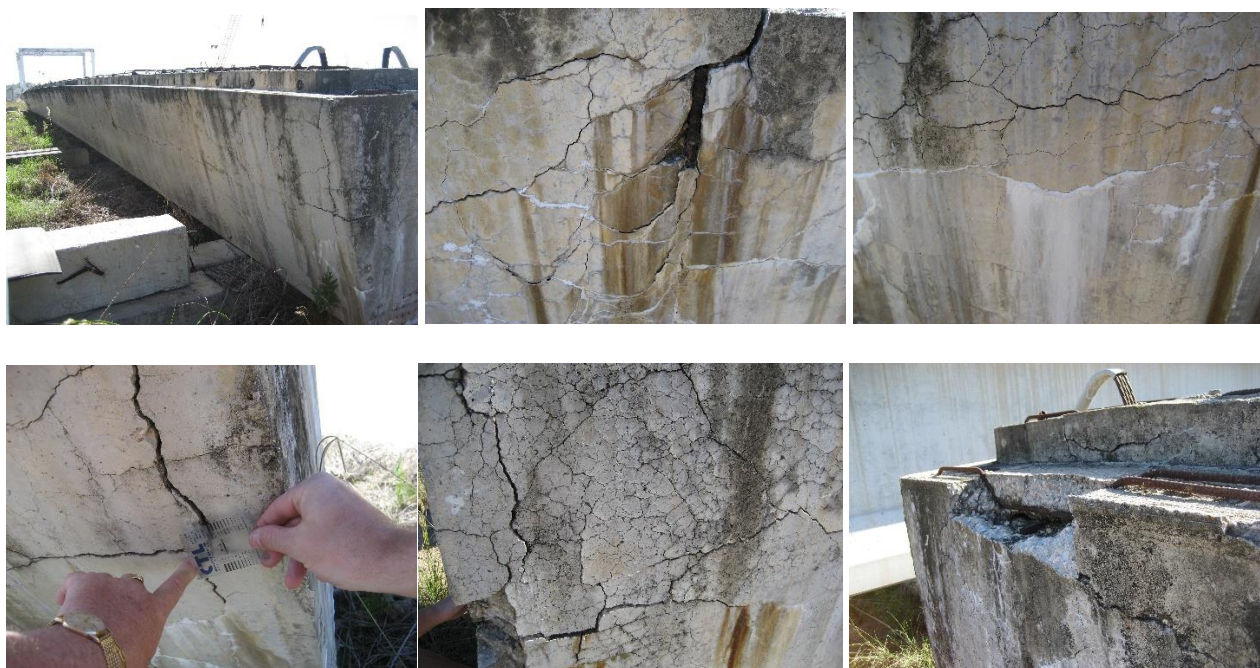
Figs. 6 – Concrete precast beam steam cured in a temperature greater than 70°C , and the scenario of cracks due to DEF.
